**BUREAU OF SHIPS GROUP
TECHNICAL INSPECTION REPORT**

OPERATION CROSSROADS.
U.S.S. LCT's 705, 816, 818, 874, 1013,
1078, 1112, 1113

TEST ABLE

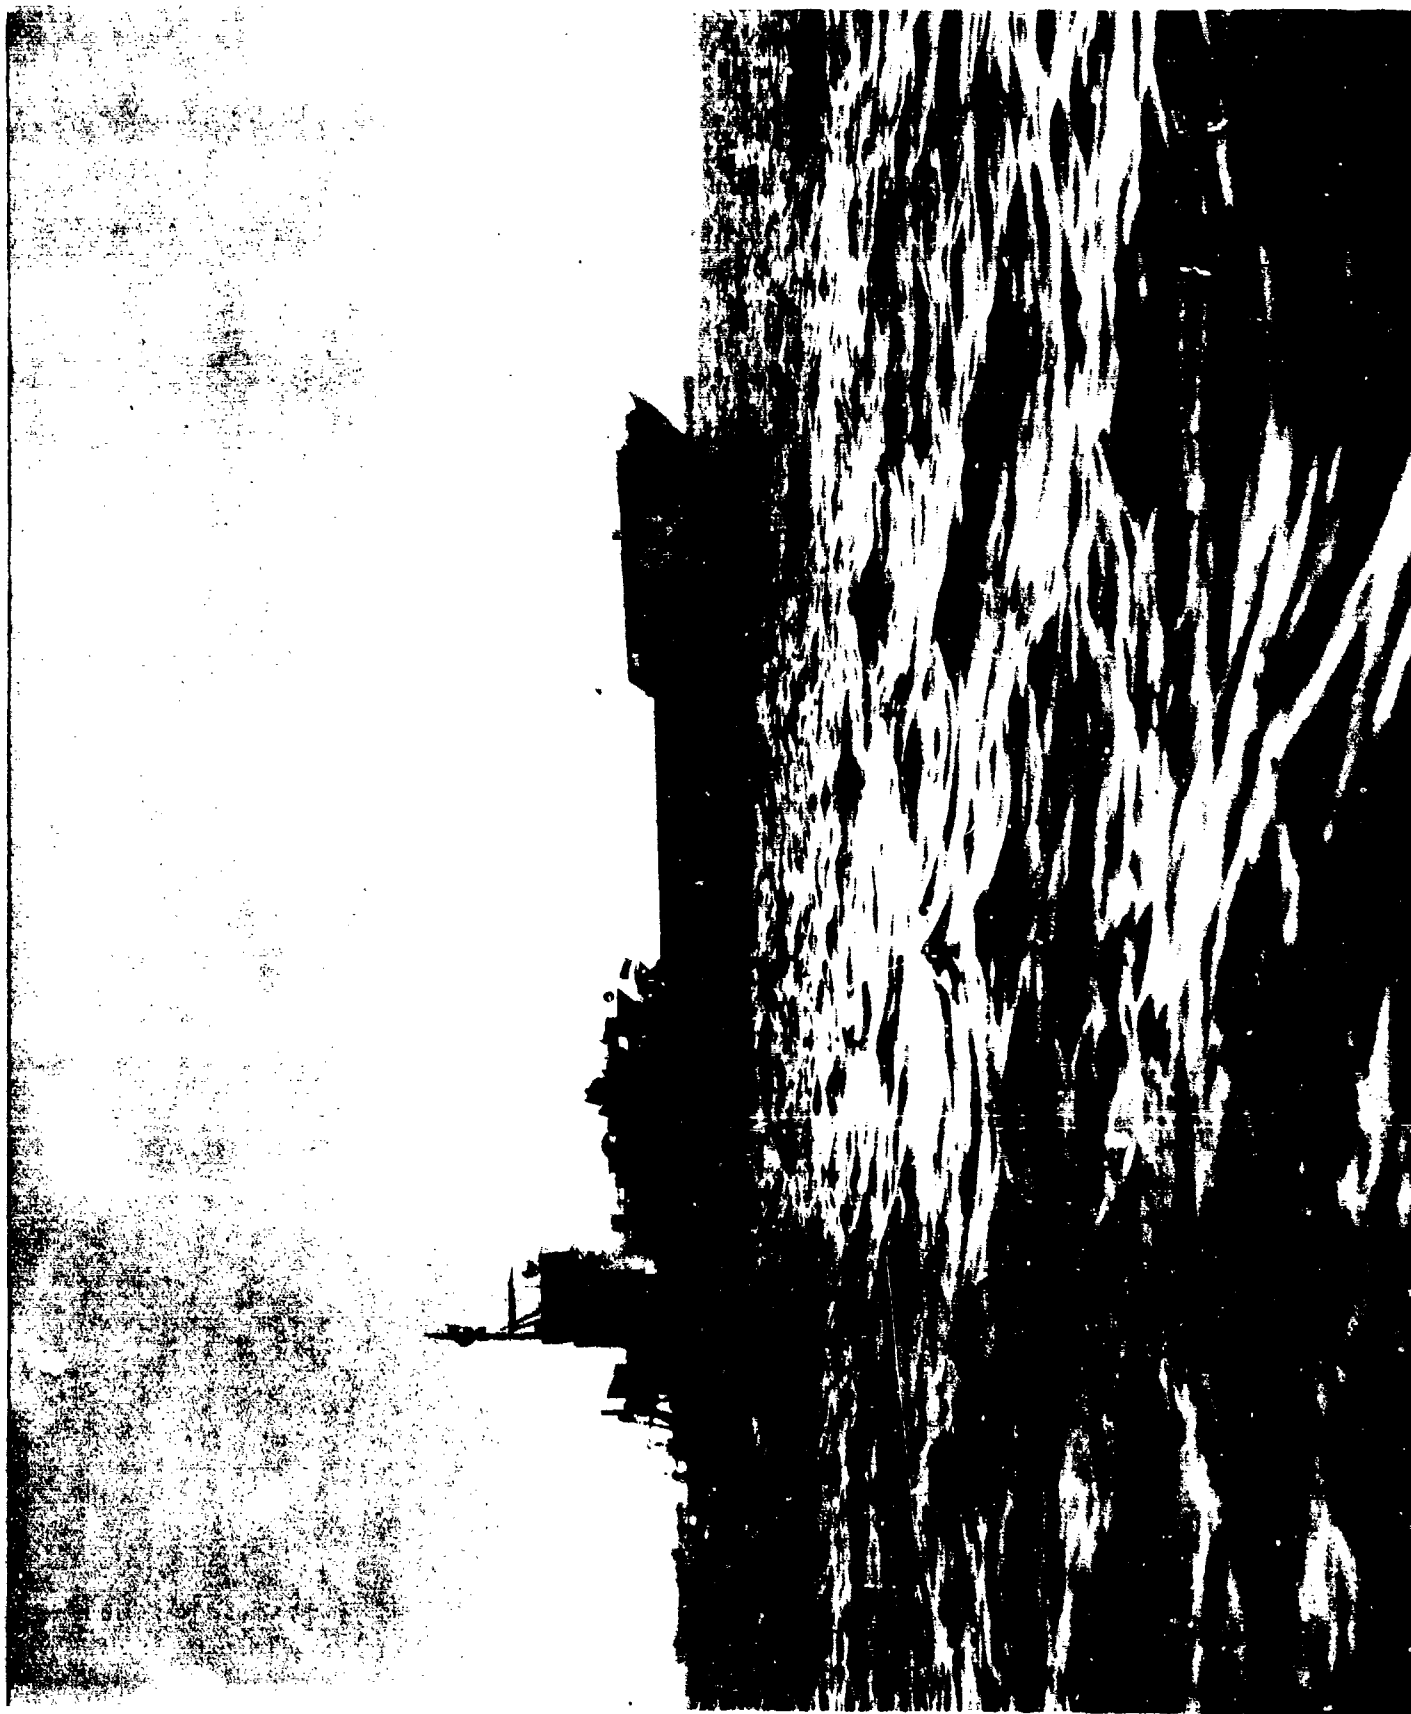
BA-CR-196-165-5. View from off starboard beam before Test A.

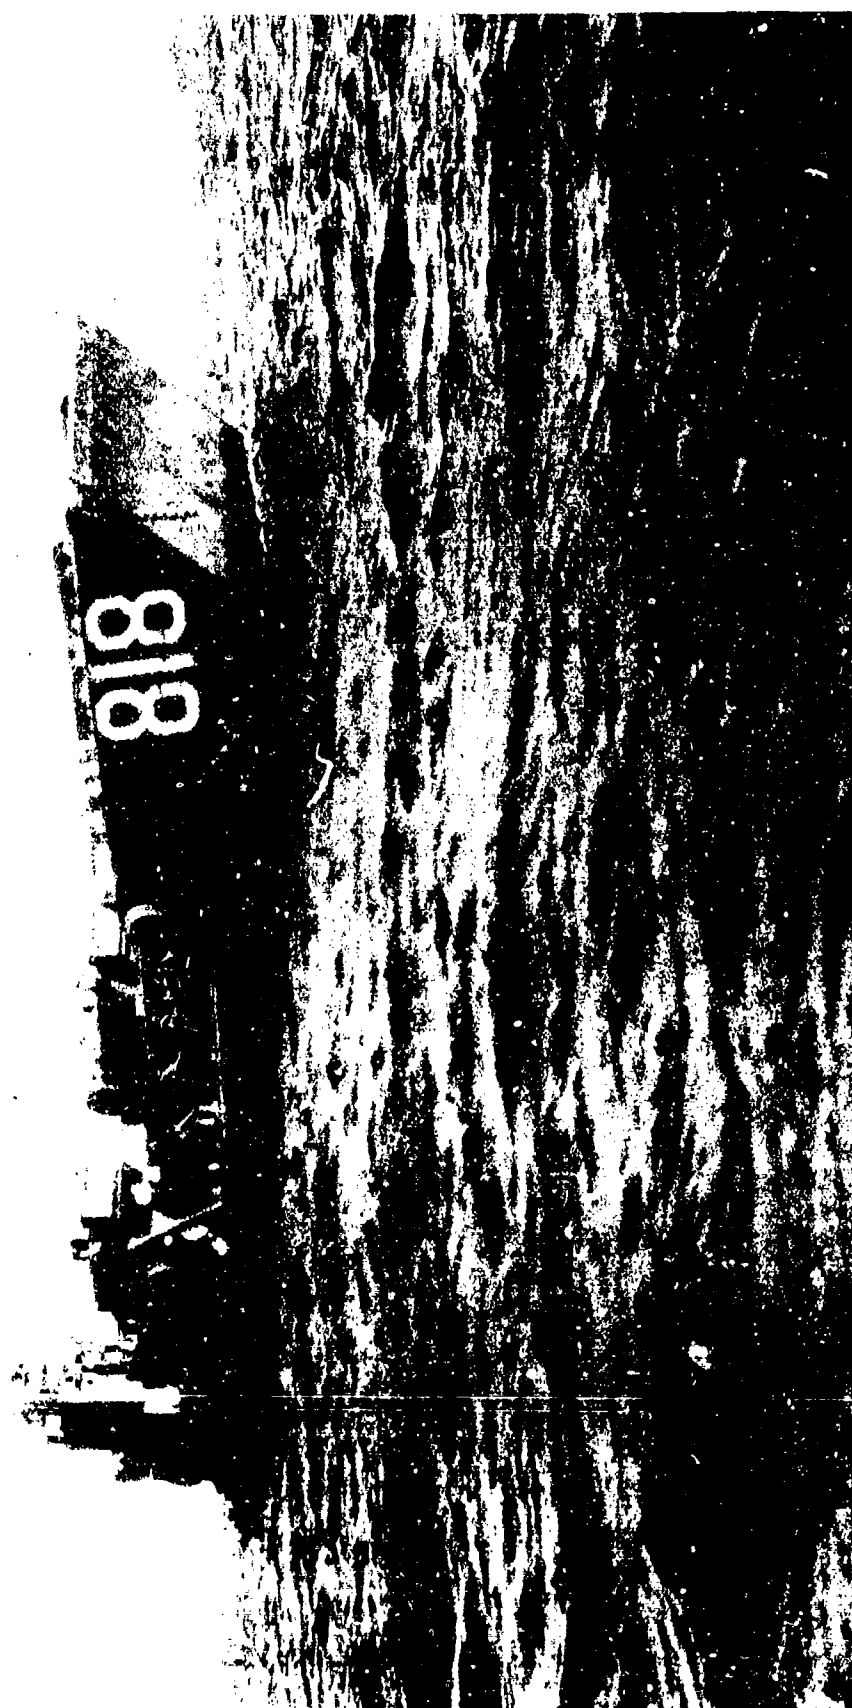
BA-CR-196-165-13. View from starboard bow before Test A.

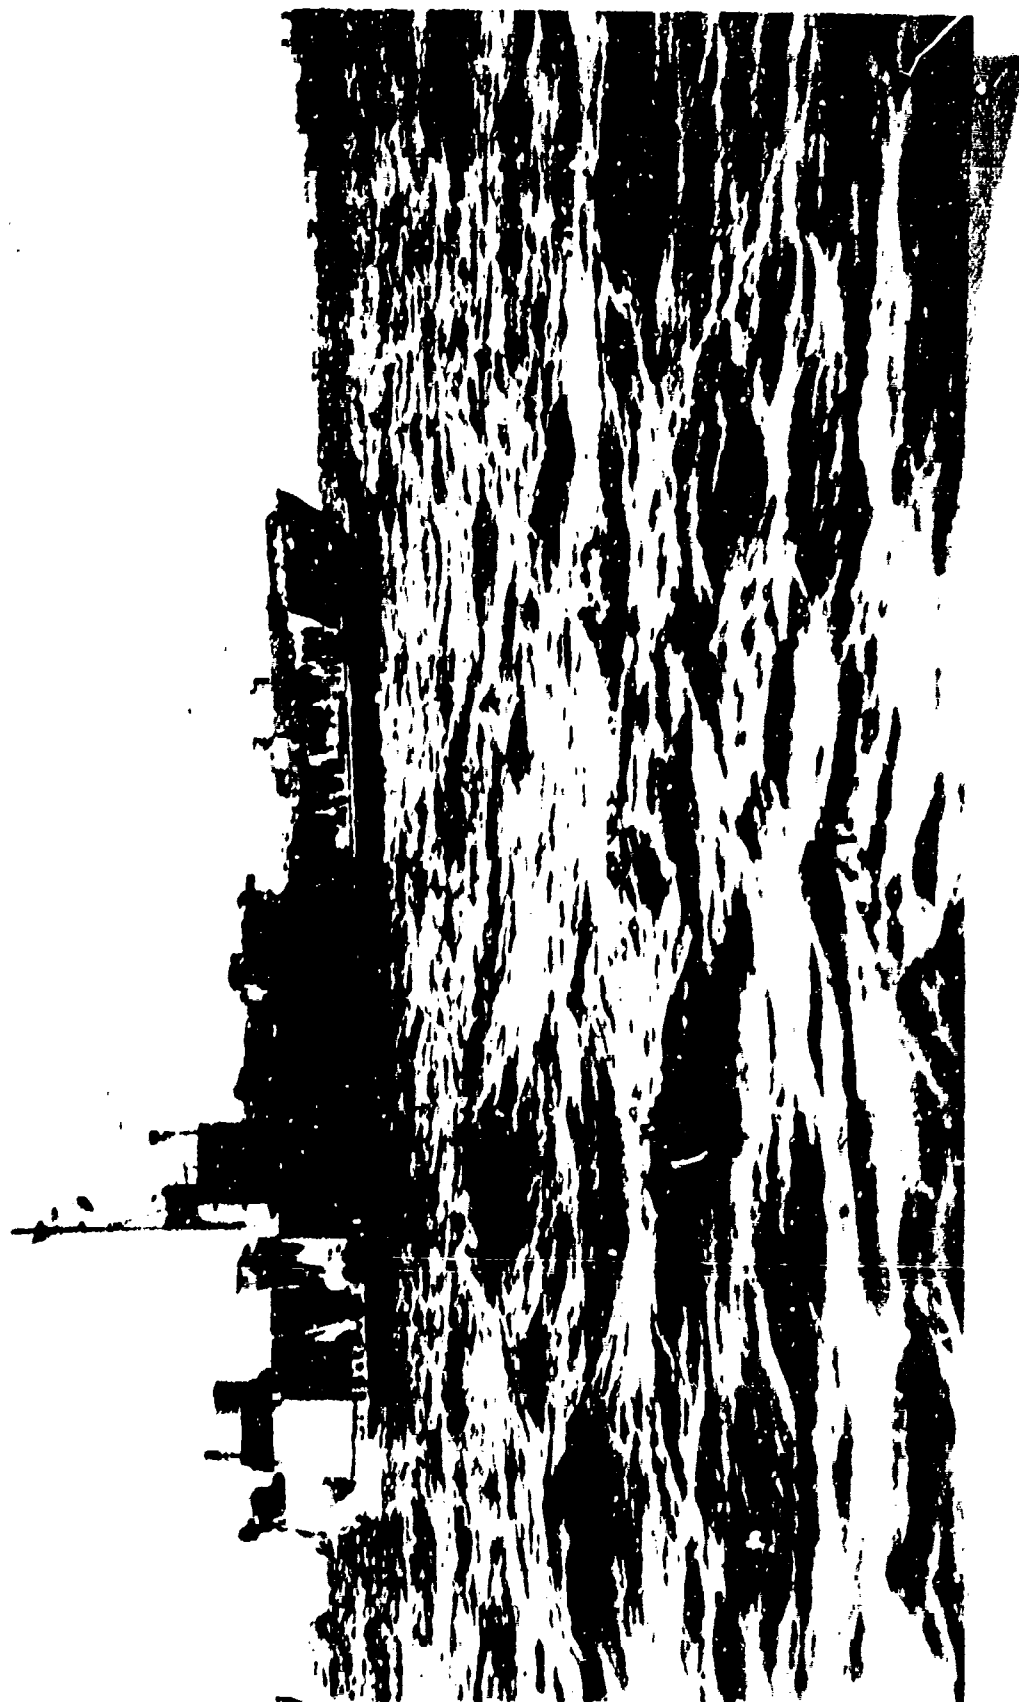
BA-CR-196-188-3. View from starboard quarter before Test A.
